Montrose Home Inspectors, Inc.

Property Inspection Report

Client(s): **First Mock**
Property address: **65546 Solar Rd**
Montrose, CO. 81403
Inspection date: **Saturday, February 18, 2017**

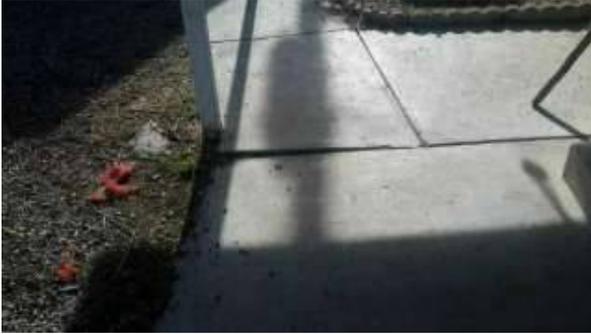
Photo 2-1

Cracks, holes, settlement, heaving and/or deterioration resulting in trip hazards were found in the sidewalks or patios. For safety reasons, recommend that a qualified contractor repair as necessary to eliminate trip hazards.

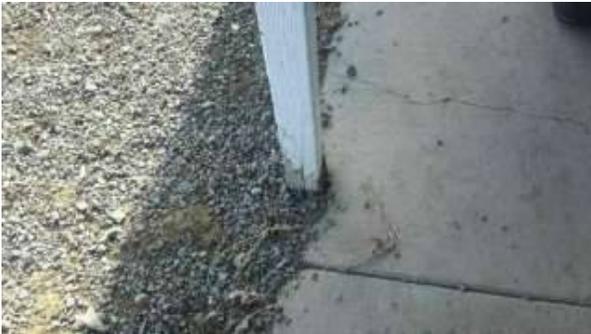
Photo 3-1

Fungal rot was found in support posts at one or more structures covering decks, patios and/or porches. Recommend that a qualified person repair as necessary. All rotten wood should be replaced.

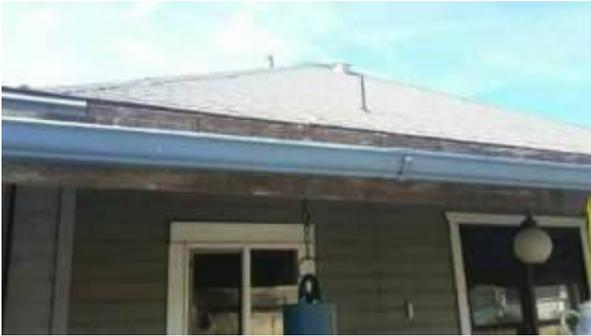
Photo 6-1

Flashing at one or more locations was missing and/or damaged. Leaks can occur as a result. Recommend that a qualified person repair, replace or install flashing as necessary, and per standard building practices.

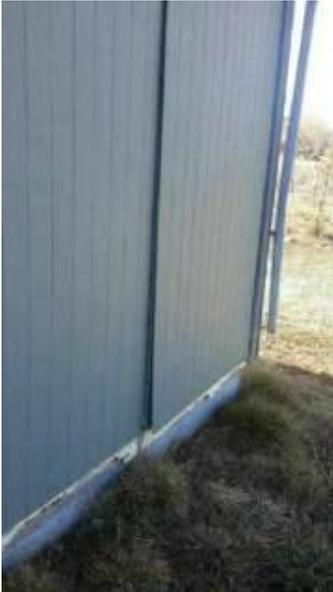
Photo 7-1

Many sections of siding and/or trim were deteriorated, loose and/or warped. Recommend that a qualified person repair, replace or install siding or trim as necessary.

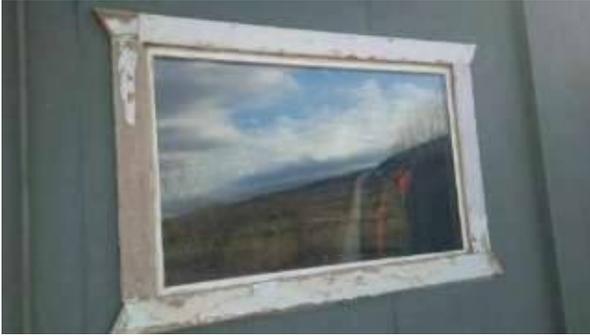
Photo 8-1

The paint or stain finish over much of the entire structure was failing (e.g. peeling, faded, worn, thinning). Siding and trim with a failing finish can be damaged by moisture. Recommend that a qualified contractor prep (e.g. clean, scrape, sand, prime, caulk) and repaint or restain the entire building exterior per standard building practices. Any repairs needed to the siding or trim should be made prior to this.

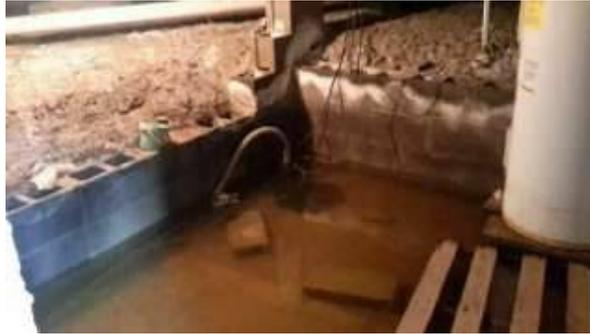
Standing water was found in one or more sections of the basement. Accumulated water can be a conducive condition for wood-destroying organisms and should not be present in the basement. Review any disclosure statements available and ask the property owner about past accumulation of water in the crawl space. Recommend that a qualified contractor who specializes in drainage issues evaluate and repair as necessary. Typical repairs for preventing water from accumulating in basements include:

- Repairing, installing or improving rain run-off systems (gutters, downspouts and extensions or drain lines)
- Improving perimeter grading

- Repairing, installing or improving underground footing and/or curtain drains

Ideally, water should not enter basements, but if water must be controlled after it enters the basement, then typical repairs include installing a sump pump.

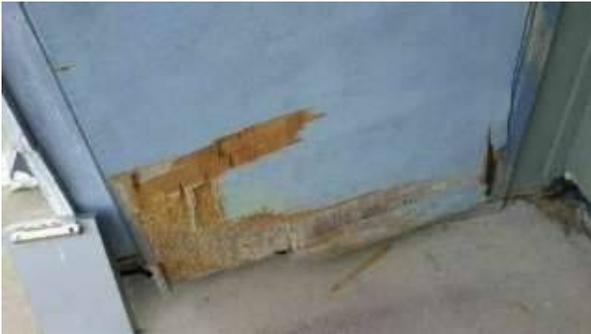
Photo 12-1

One or more exterior doors were significantly damaged or deteriorated. Recommend that a qualified person replace door(s) as necessary.

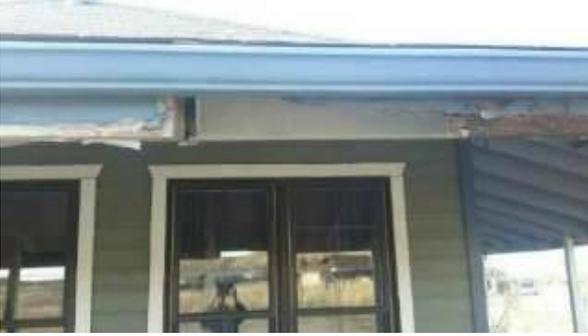
Photo 14-1

14) 🪛 Fungal rot or significant water damage was found at one or more roof areas at fascia boards. Recommend that a qualified contractor repair as necessary. For example, by replacing all rotten wood, priming and painting new wood and installing flashing.

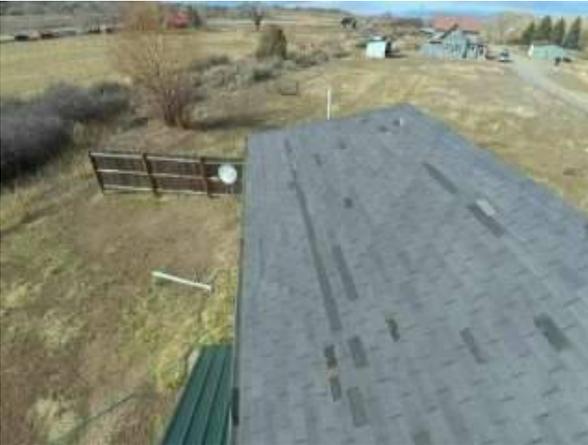
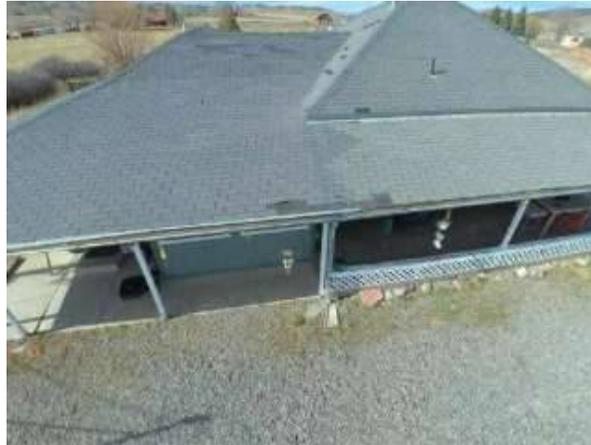
15) 🪛 Many composition shingles were cracked, broken, missing, loose and/or damaged. Leaks can occur as a result. This is a conducive condition for wood-destroying organisms. Recommend that a qualified contractor repair as necessary. For example, by replacing shingles.

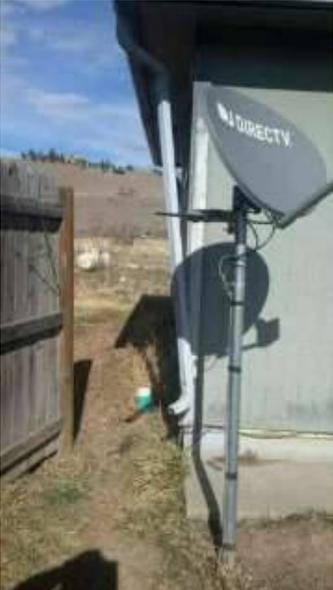
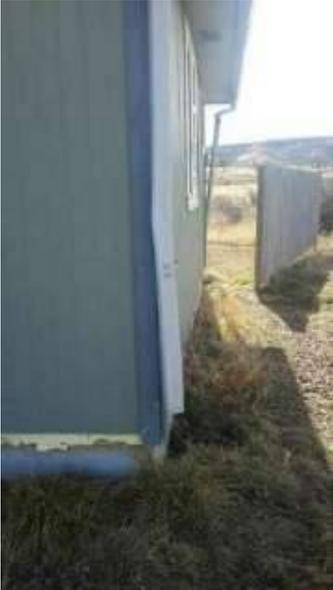
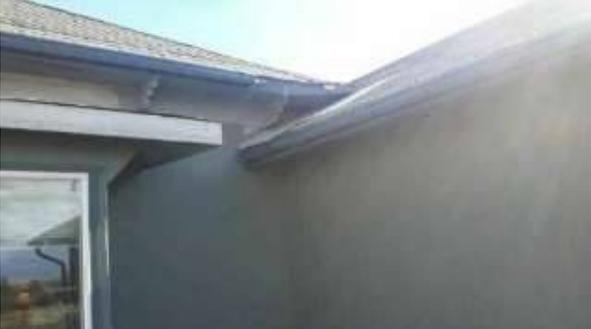
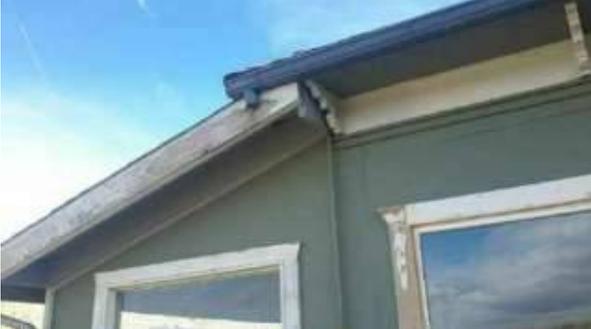
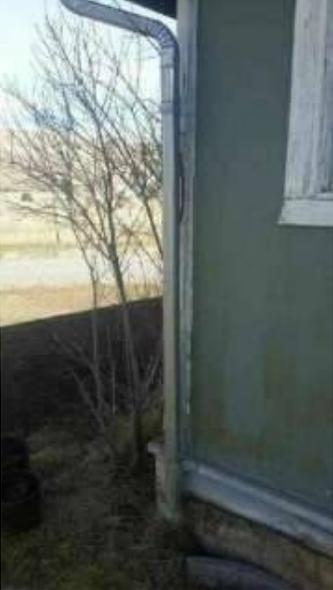
17) 🪛 One or more downspouts were loose and/or missing. Rainwater can come in contact with the building exterior or accumulate around the building foundation as a result. This is a conducive condition for wood-destroying organisms. Recommend that a qualified person repair as necessary.

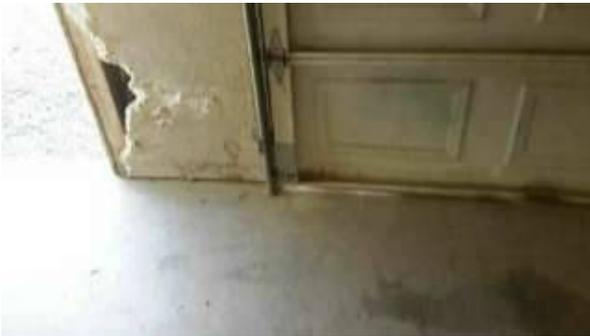
Photo 18-1

No photoelectric sensors were installed for one or more garage vehicle doors' automatic opener. These have been required on all automatic door openers since 1993 and improve safety by triggering the door's auto-reverse feature without need for the door to come in contact with the object, person or animal that is preventing the door from closing. Recommend that a qualified contractor install photoelectric sensors where missing for improved safety. For more information on garage door safety issues, visit:

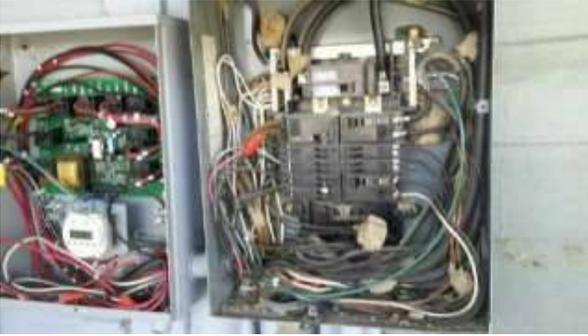
Photo 23-1

Panel(s) #A had inadequate working space. This is a safety hazard when opening or working in panels. Electric panels should have the following clearances:

Also hornets appeared inside pane.

Recommend that a qualified contractor repair or make modifications per standard building practices. If panels must be opened for repairs, then a qualified electrician should perform repairs.

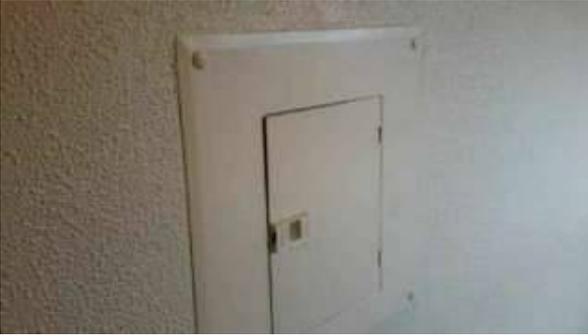
Photo 30-1

The inspector was unable to open and evaluate panel(s) #B and C because items were blocking access and/or paint, caulk or wallpaper would be damaged. These panel(s) are excluded from this inspection. Recommend that repairs, modifications and/or cleanup should be made as necessary so panels can be opened and fully evaluated.

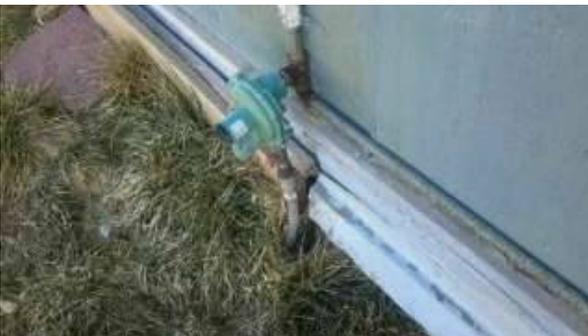
Photo 32-1

Steel piping for the gas service located outside was significantly corroded. Gas leaks can result. Recommend evaluation by a qualified contractor to determine if piping needs replacing. If not, then a qualified person should prep and paint lines as necessary with a rust-preventative paint. Very corroded pipes should be replaced by a qualified contractor.

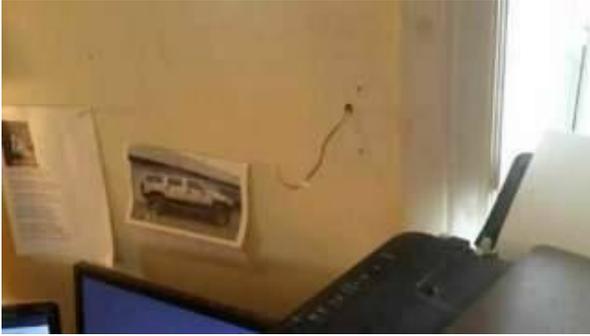
Photo 37-1

Thermostat for gas stove is missing this is a safety hazard recommend further evaluation by licensed heating contractor
